Technical Report CHL-97-5
March 1997

Monitoring Completed Navigation Projects Program

Burns Harbor, Indiana, Monitoring Study

Volume I: Overview of Approach and Results

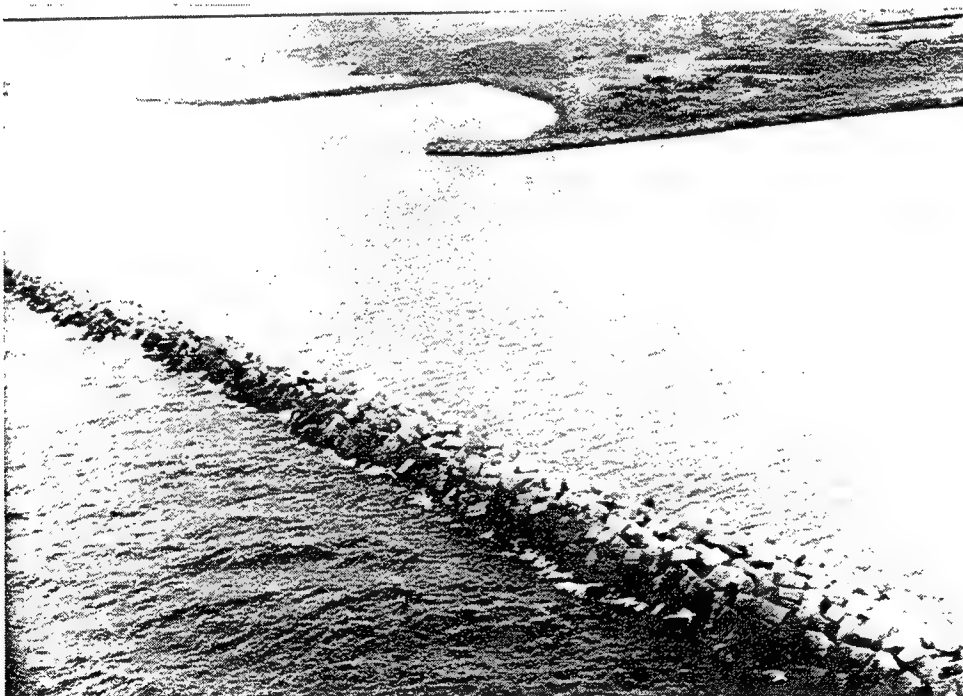
b. 1987 lakeside view

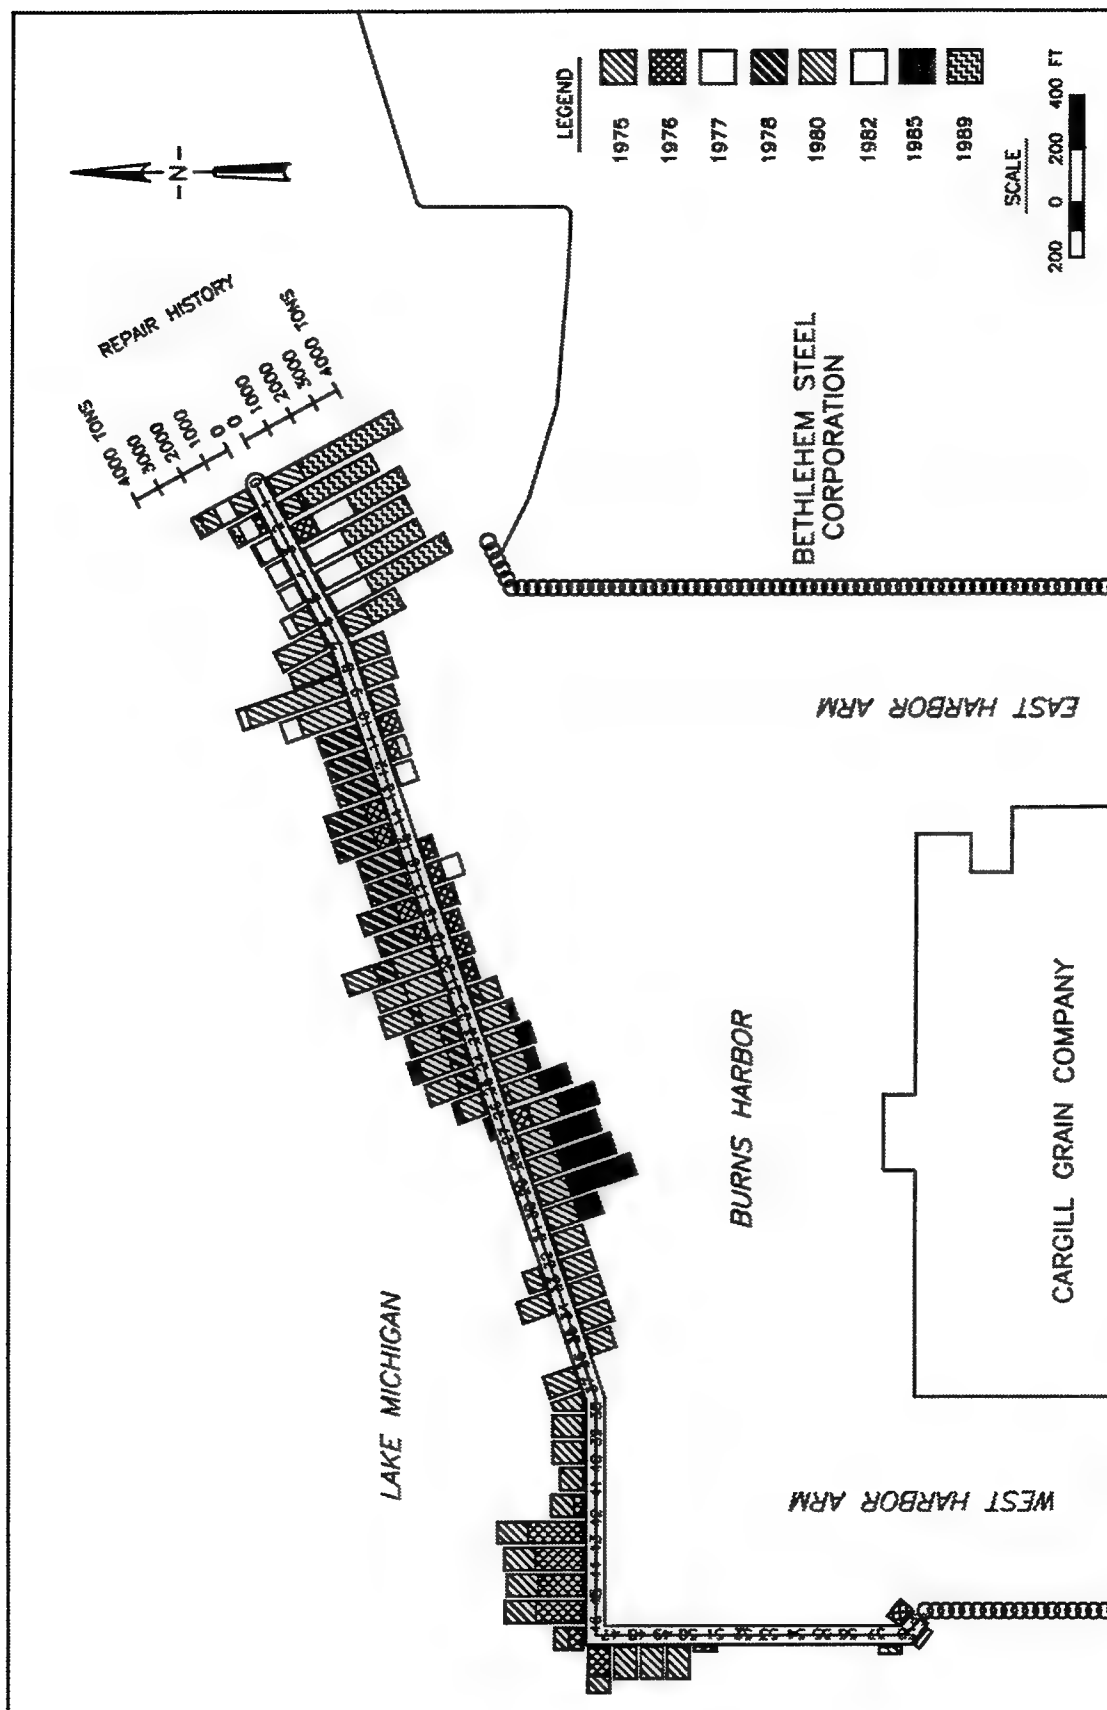
Repairs of armor stone on both the lakeside and harborside were scheduled for the next 5 years, commencing in the summer of 1975. A report of inspection by the NCC District Geologist in July of 1975 declared the structure to be in better than expected condition, but the following summer, the IPC was repeating its request for repair work. A pattern of damage and repair continued through the 80's, with some sections receiving repeated maintenance. Figure 14 records the history of repairs by year, tonnage, and location. Amounts of repair stone placed each year and cumulatively are provided in Table 2; the total is 78 percent of the original armor amount. The maintenance stone placed on the breakwater, except for the 1989 repair, was limestone with a specific weight of 145 pcf. The 1989 repair utilized quartzite with a specific weight of 175 pcf. Figure 15 is a time line providing an overview of wave conditions (from WIS) and major events in the history of the structure.

Figure 14. Breakwater repair history

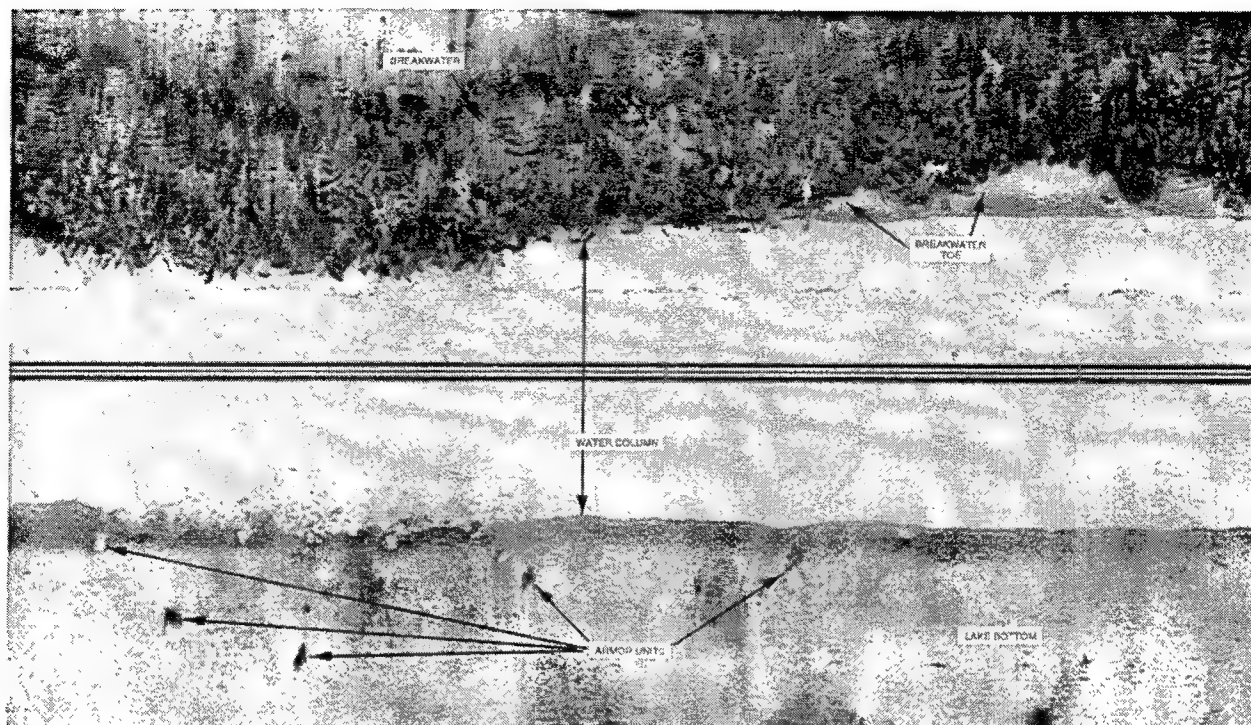
Figure 19. Lakeside SSS record showing individual armor units

the structure slope, some reflectors are visible below the upper mud layer, indicating stone projects further out than the visible toe at -32 ft.

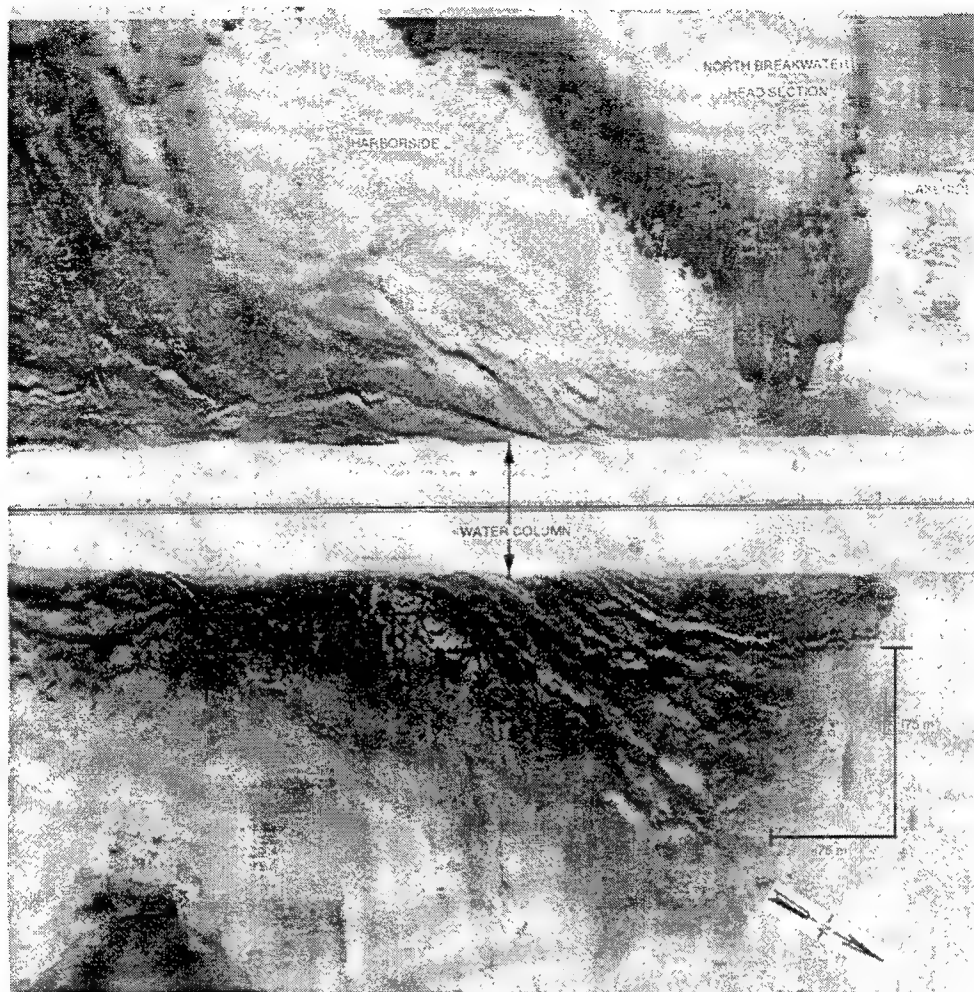
Figure 21. SSS record of scour features at harbor entrance

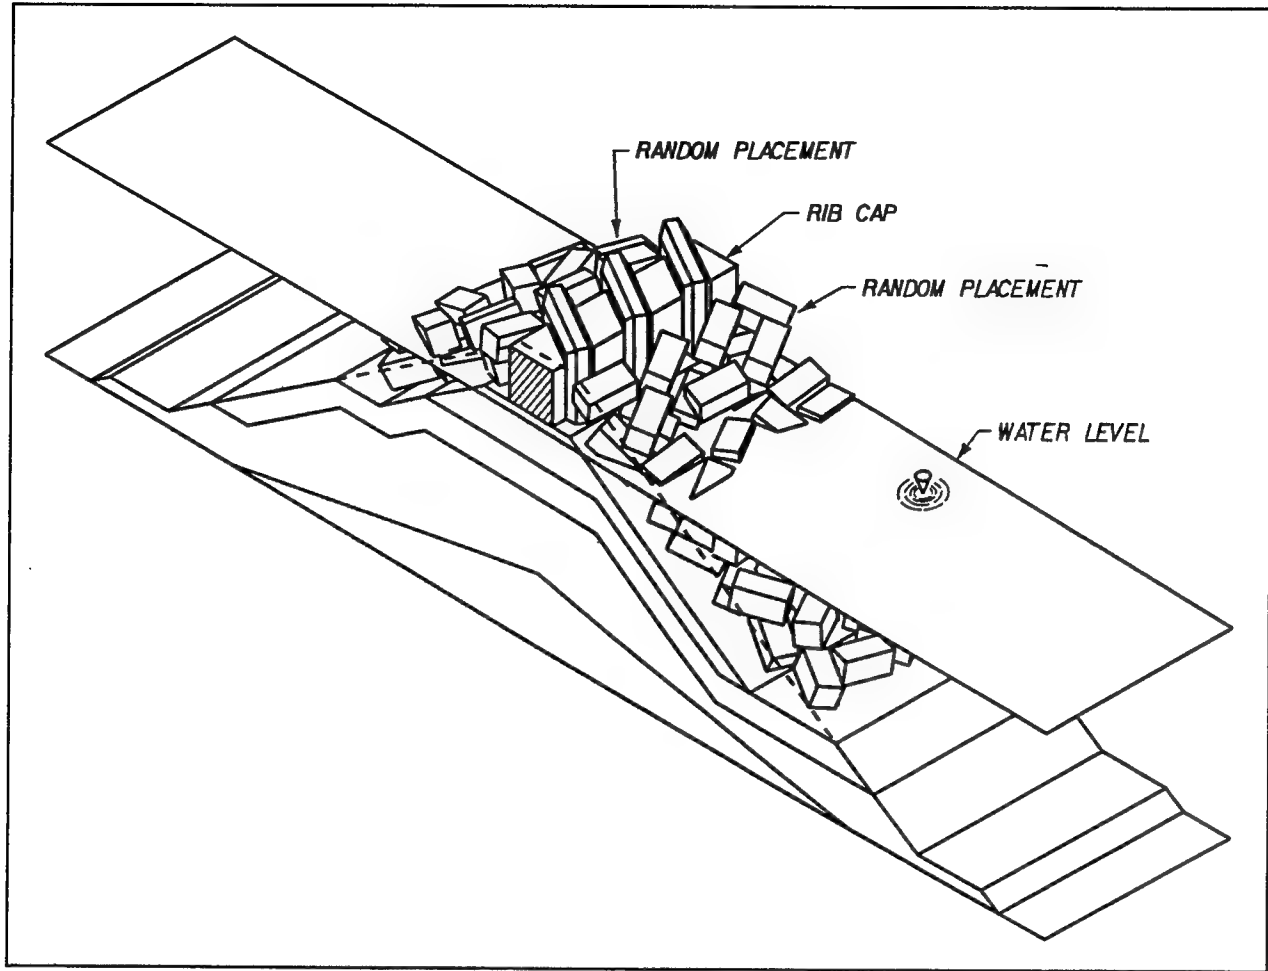
Figure 37. Illustration of rib cap

- b. Seal the structure. Some options are available to tighten the structure by sealing voids with grout or asphalt. The long-term durability of these options is not well-known. It is possible that the existing armor

could be repositioned to achieve lower porosity, but those options are effectively restricted to the subaerial portion of the structure because they cannot be practically accomplished below the waterline.
